**CONESTOGA-ROVERS  
& ASSOCIATES**

## MEMORANDUM

To: Leslie Patterson, USEPA REF. No.: 038443 151  
 FROM: Adam Loney/Steve Quigley/cb/251 DATE: August 27, 2014  
 RE: Site History: South Dayton Dump and Landfill, Moraine, Ohio (Site)

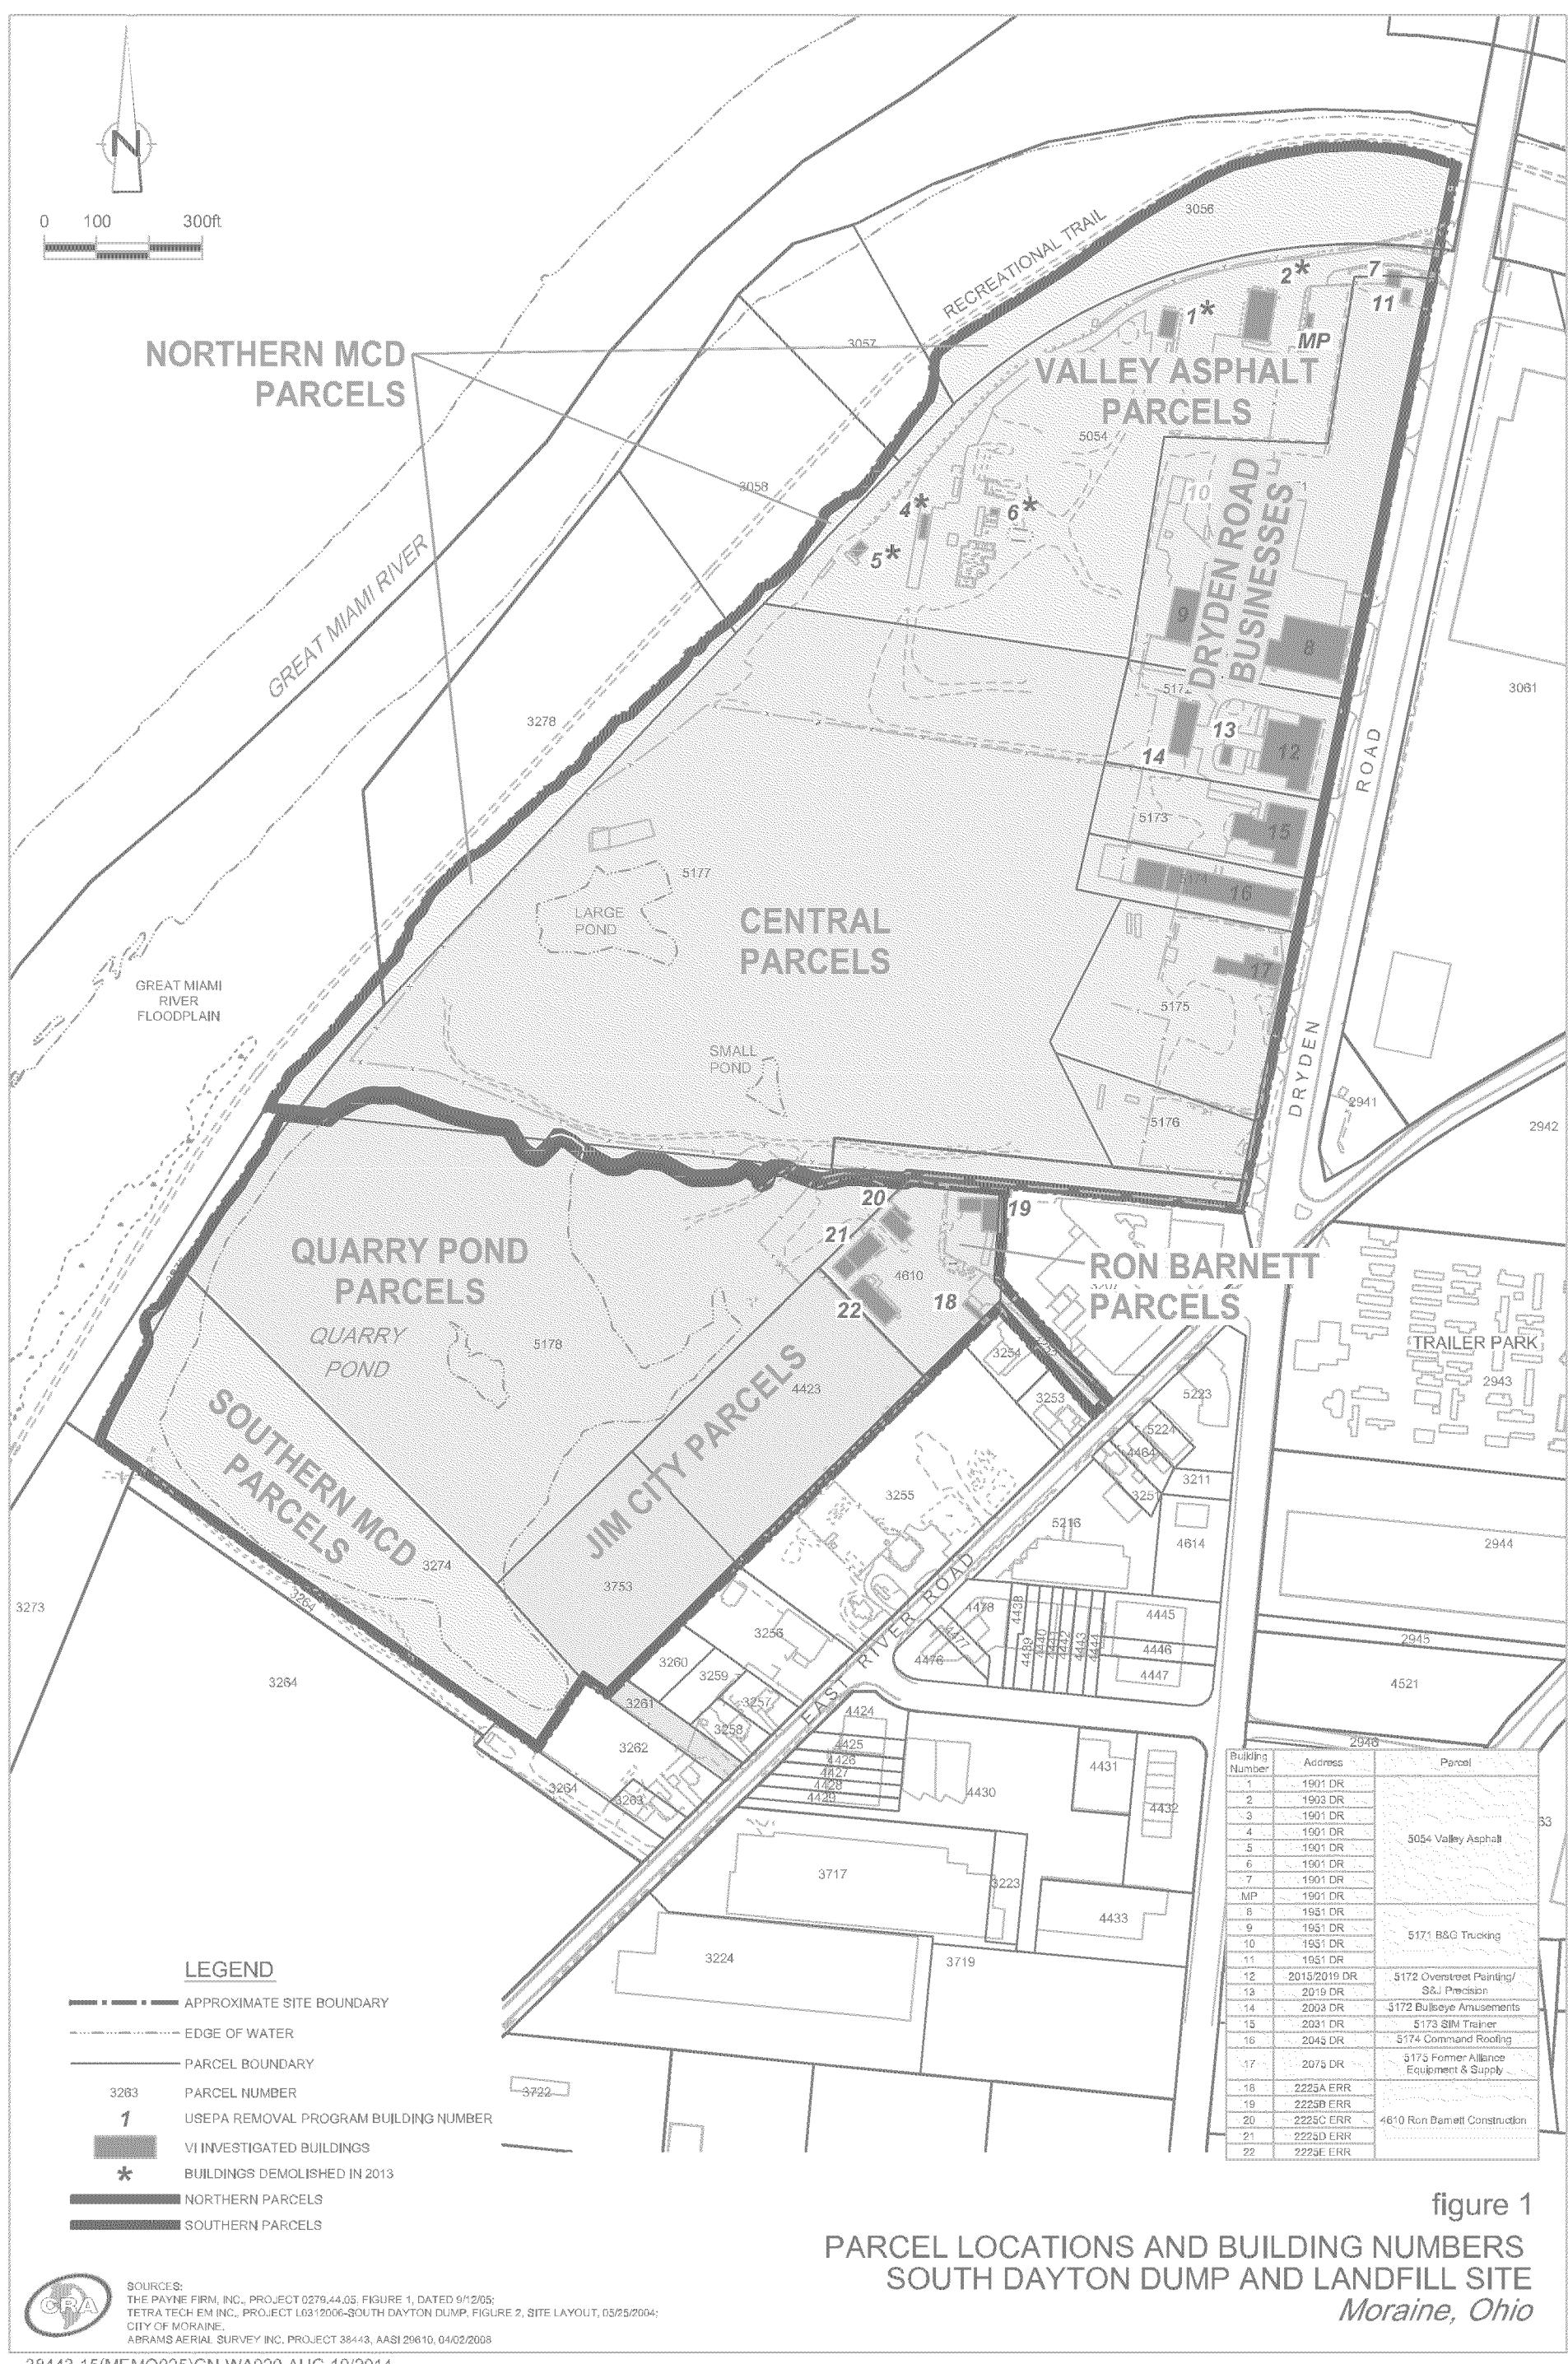
**figure 1**  
**PARCEL LOCATIONS AND BUILDING NUMBERS**  
**SOUTH DAYTON DUMP AND LANDFILL SITE**  
*Moraine, Ohio*

CRA has divided the Parcels into groups for discussion based on the sequence of filling, the types of waste and fill<sup>iii</sup>, visually observed at investigated locations, and the general location with respect to type within the Site boundary, as shown on Figure 1 and described as follows:

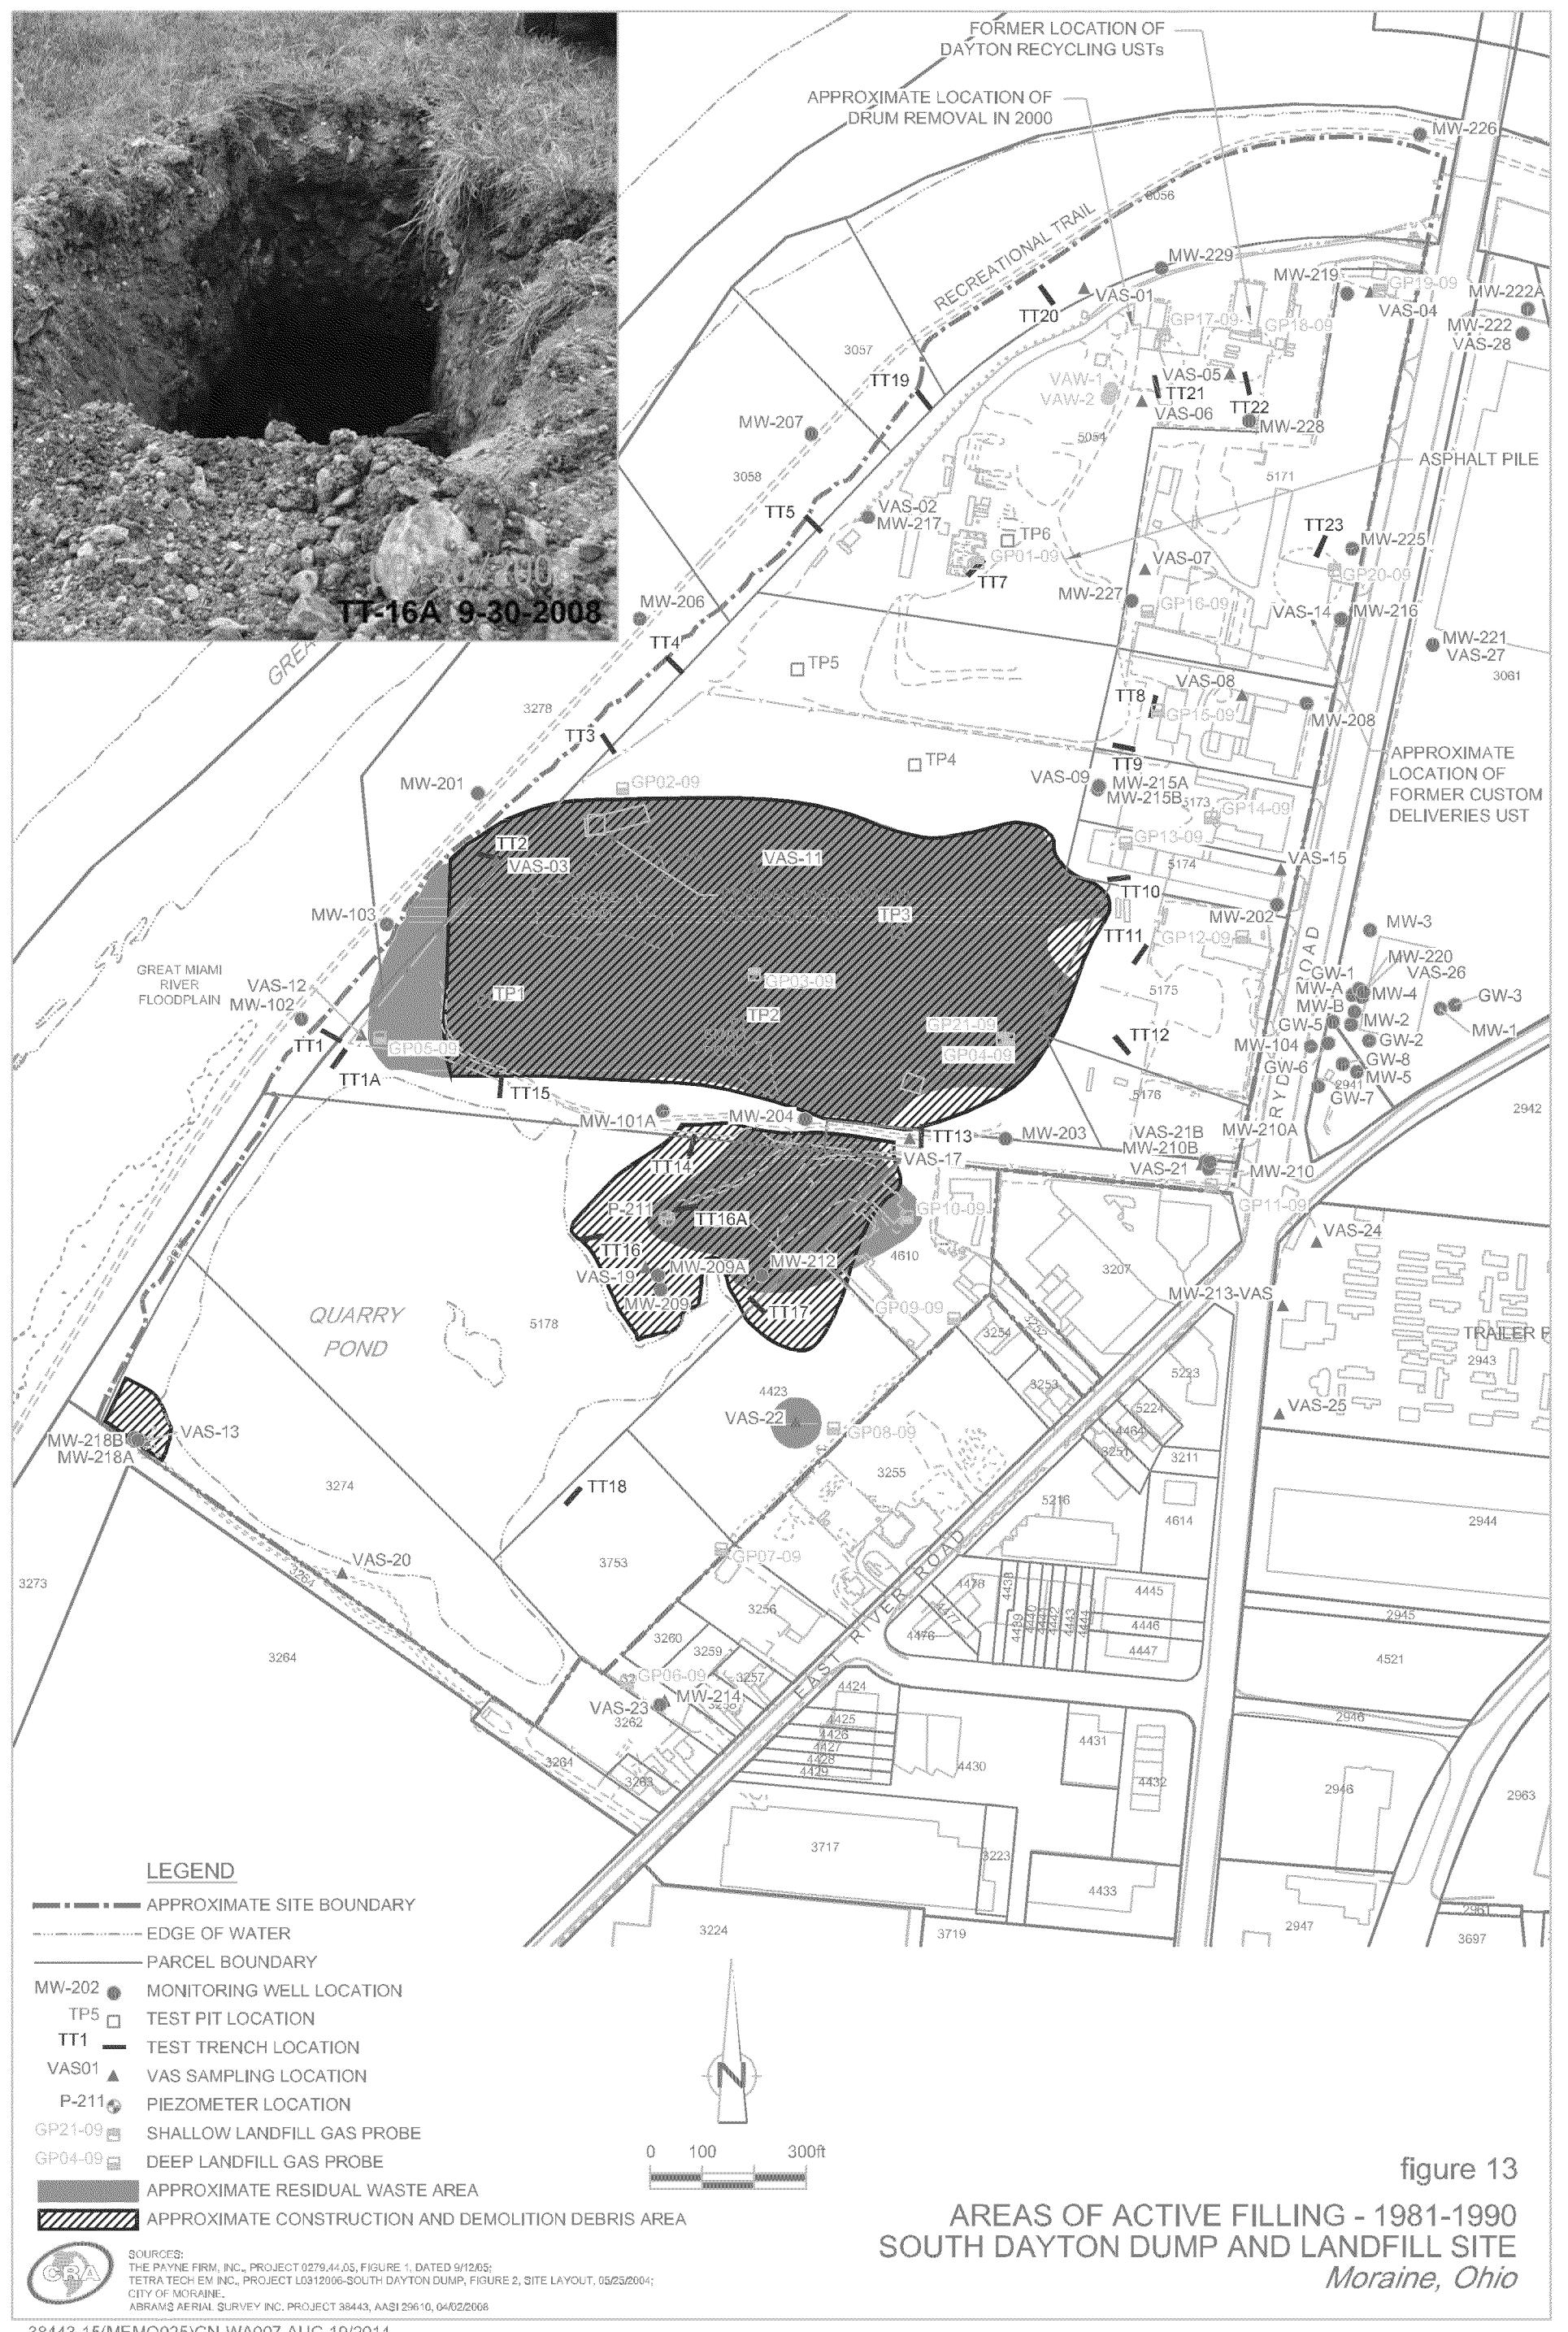
figure 13  
AREAS OF ACTIVE FILLING - 1981-1990  
SOUTH DAYTON DUMP AND LANDFILL SITE  
*Moraine, Ohio*

- Putrescible wastes were not accepted. Fill material, including some industrial solid waste, residual waste, and CDD, was placed on this portion of the Site (Figure 7).  
ffl 1969 - 1975: Operation of an approximately 15 acre portion of the Site as a licensed solid waste landfill subject to the requirements of HE 24 and accepting non putrescible industrial, residual, and household wastes as well as CDD (Figure 9).  
ffl 1976 - 1980: Operation of an approximately 17 acre portion of the Site as a licensed solid waste landfill subject to the requirements of the 1976 version of Ohio Administrative Code (OAC) 3745-27 and limited to the following wastes: industrial, residual, and CDD (Figure 11).  
ffl 1981 - 1990: Operation of an approximately 20 acre portion of the Site as a licensed solid waste disposal facility which only received hard fill, residual waste, and CDD and was authorized pursuant to OAC 3745-27 (Figure 13).

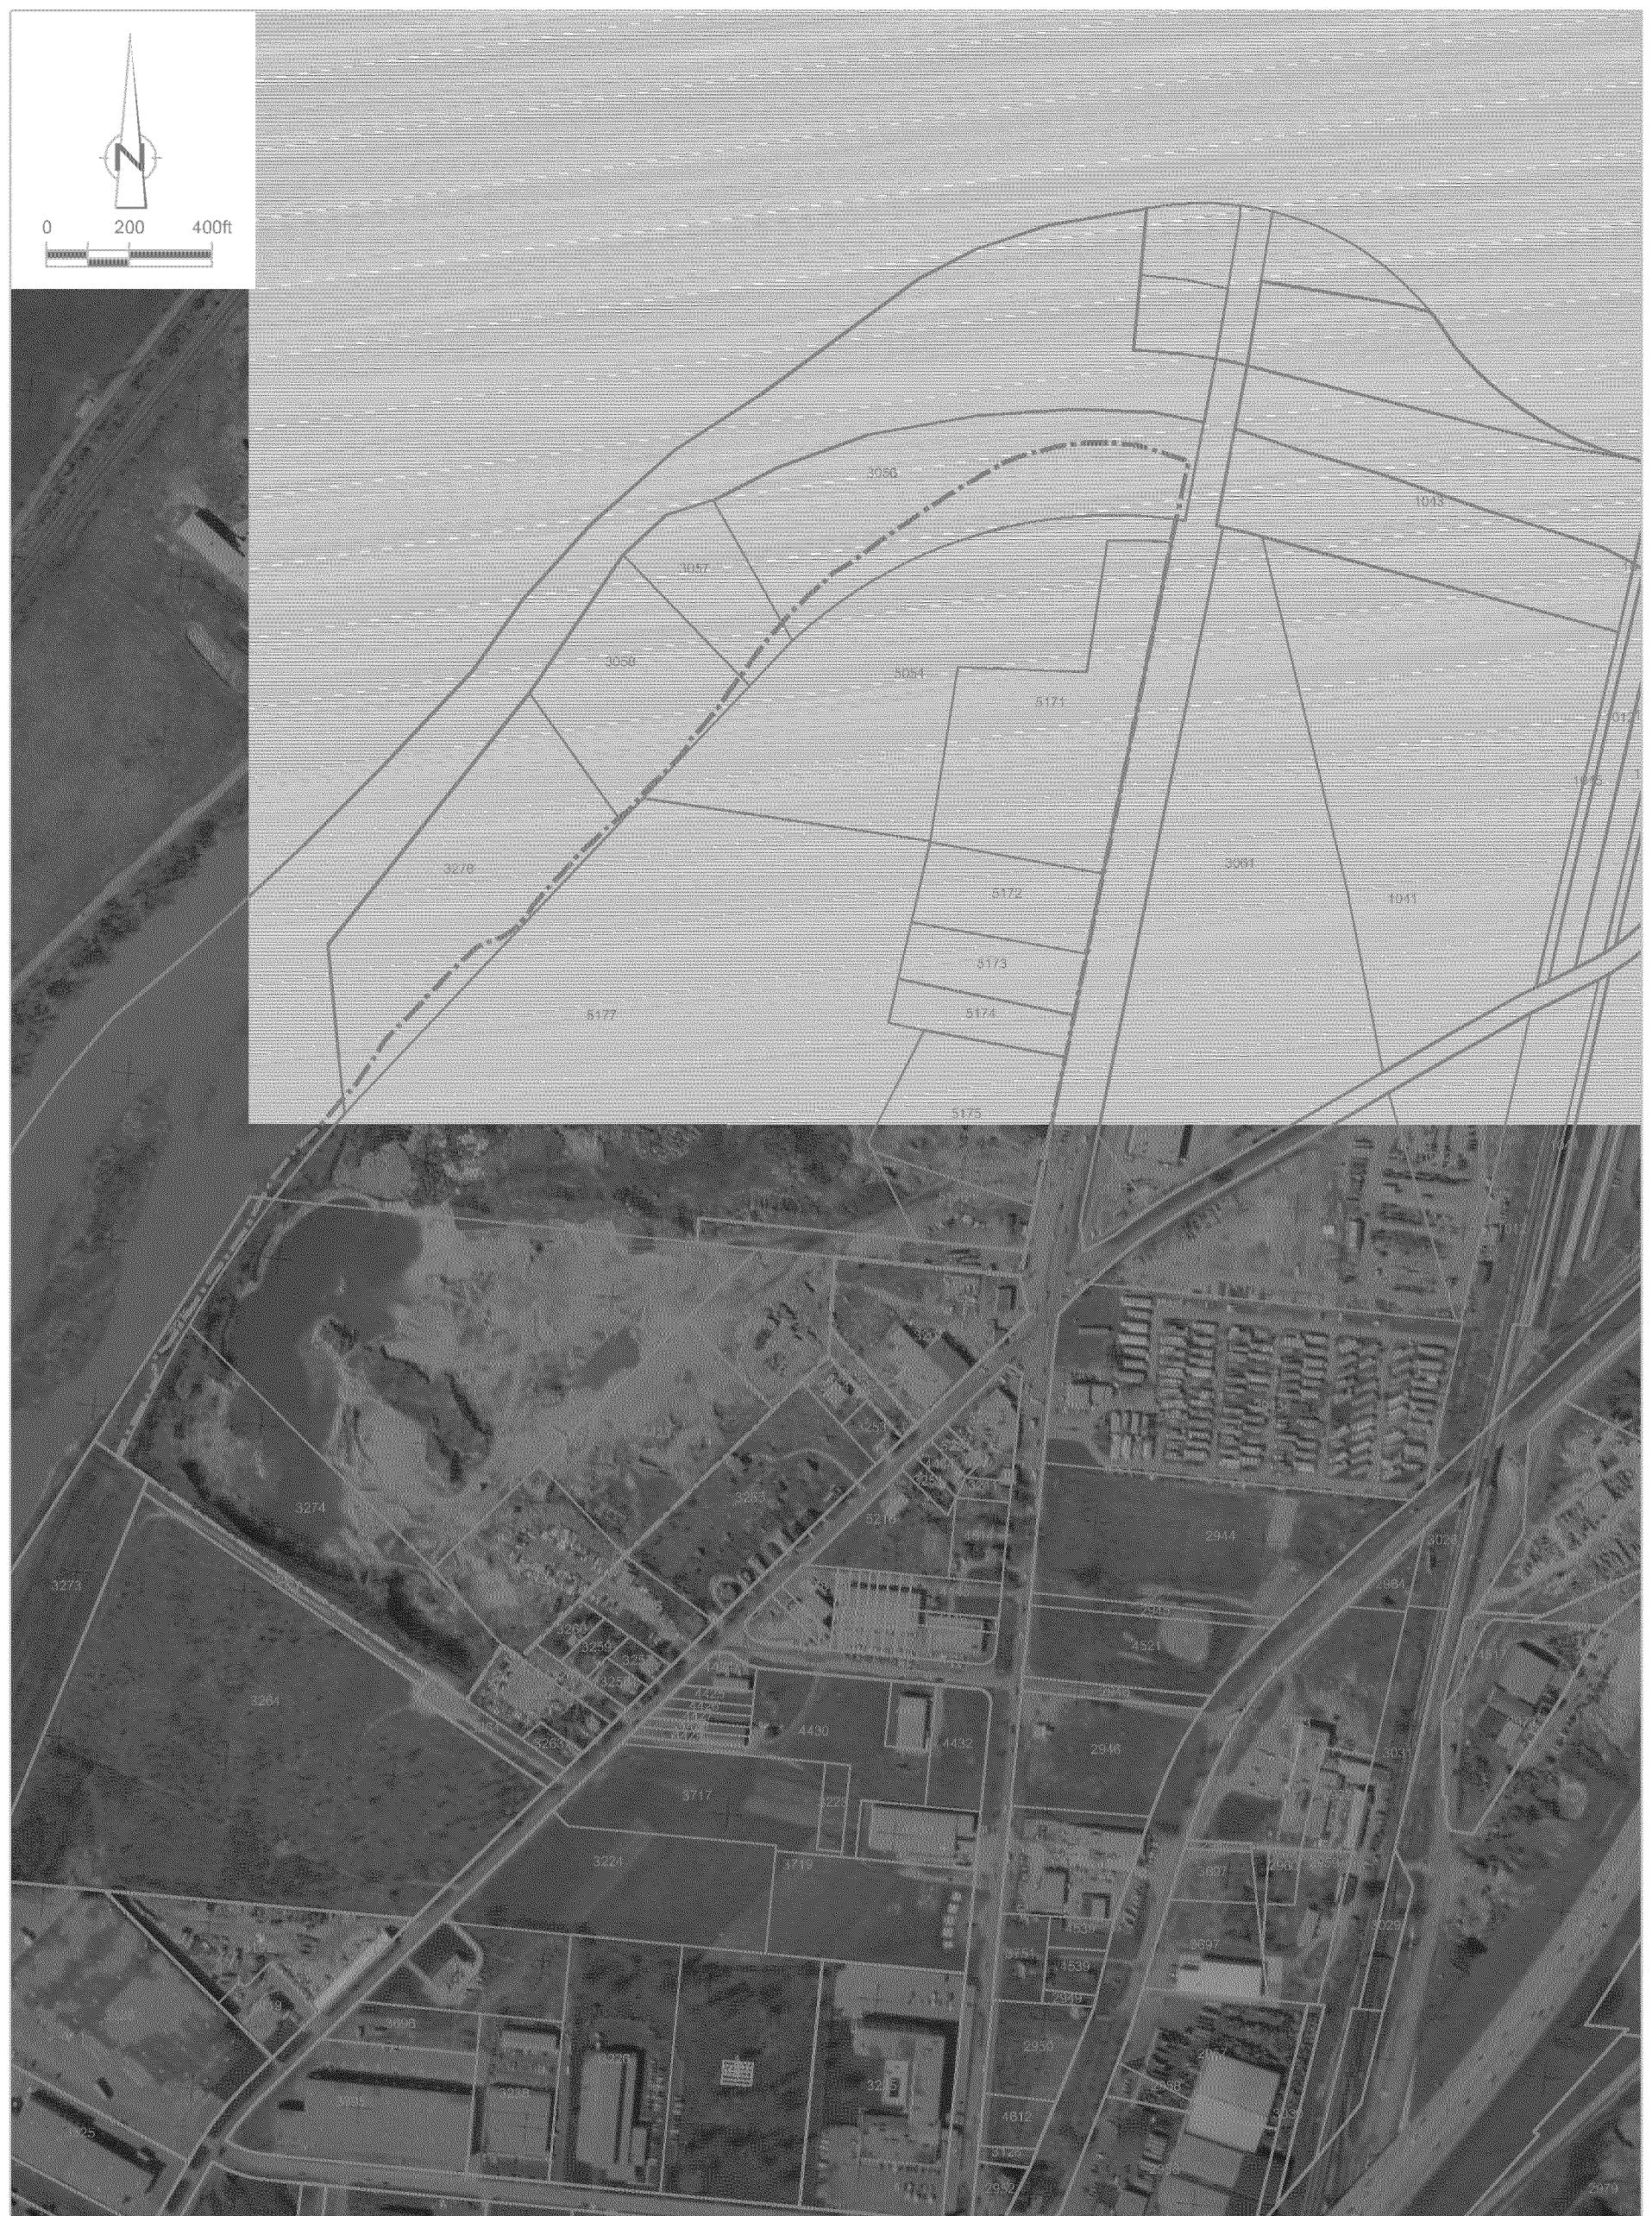
figure 20

APRIL 1973 AERIAL PHOTOGRAPH  
OU1 REMEDIAL INVESTIGATION REPORT  
SOUTH DAYTON DUMP AND LANDFILL SITE  
*Moraine, Ohio*

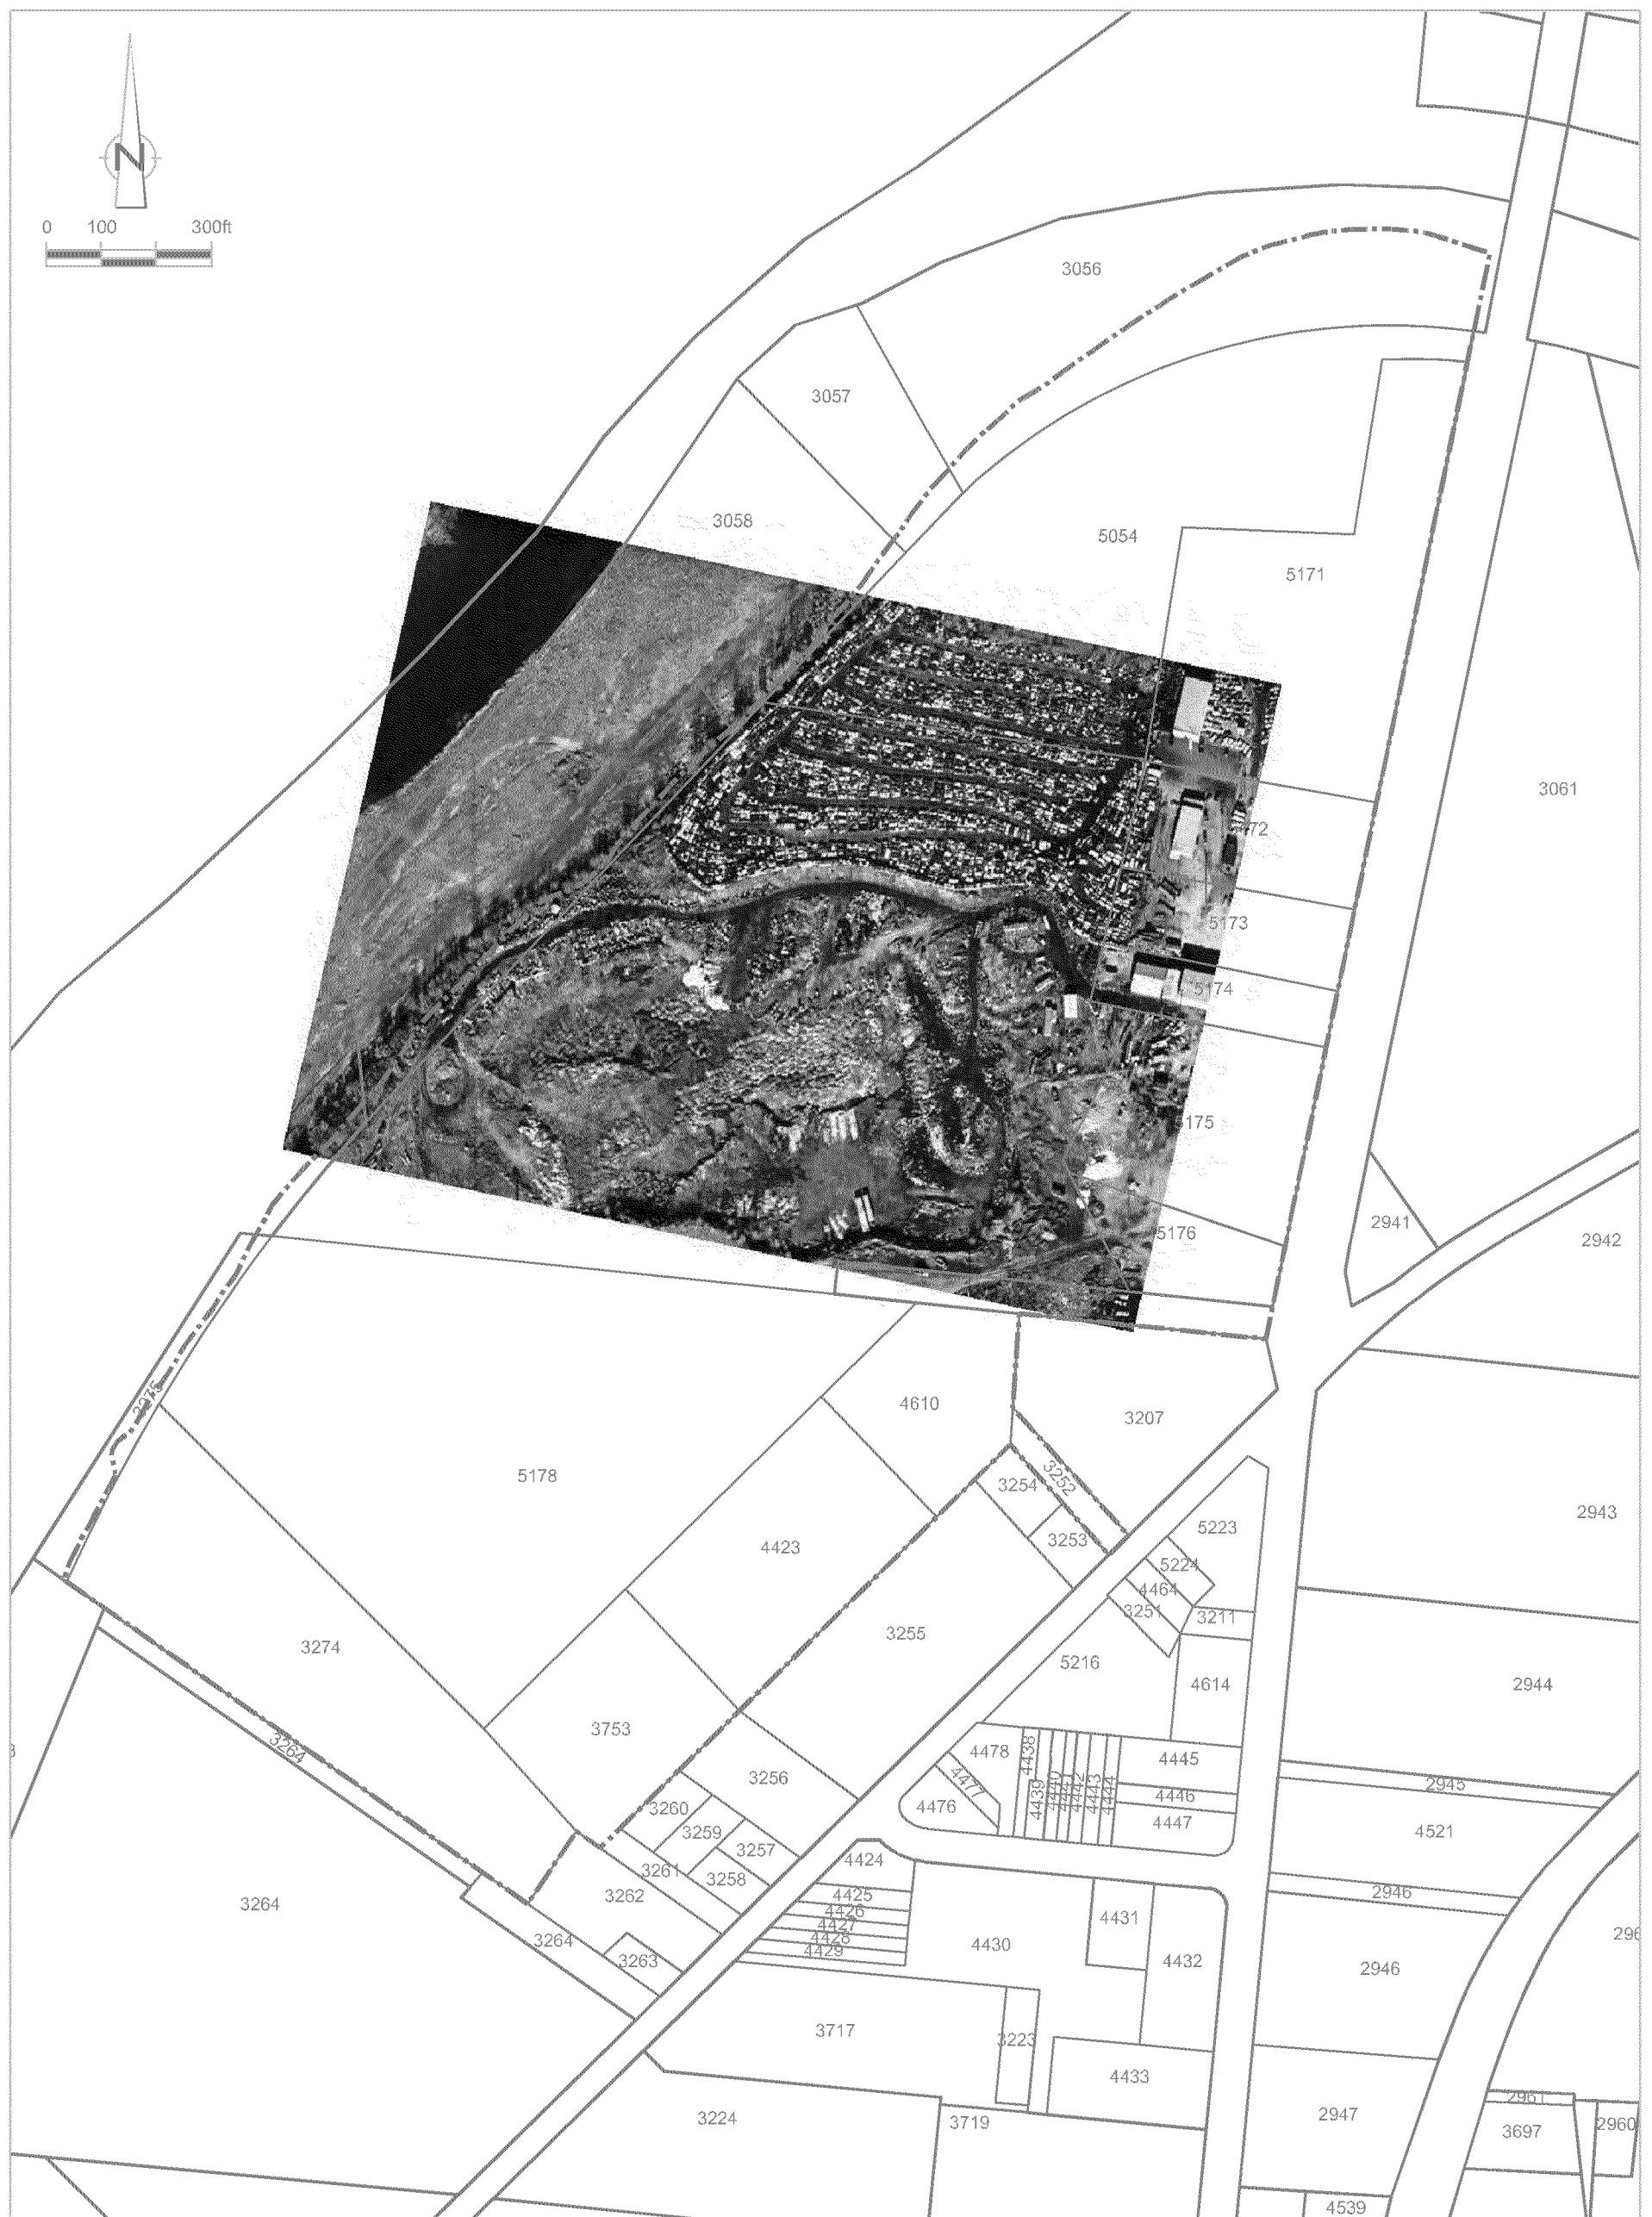
figure 21

The 1978 aerial photo (Figure 21) only shows the central portion of the Site but conditions were similar to the 1975 aerial photograph on Figure 10<sup>4</sup>.

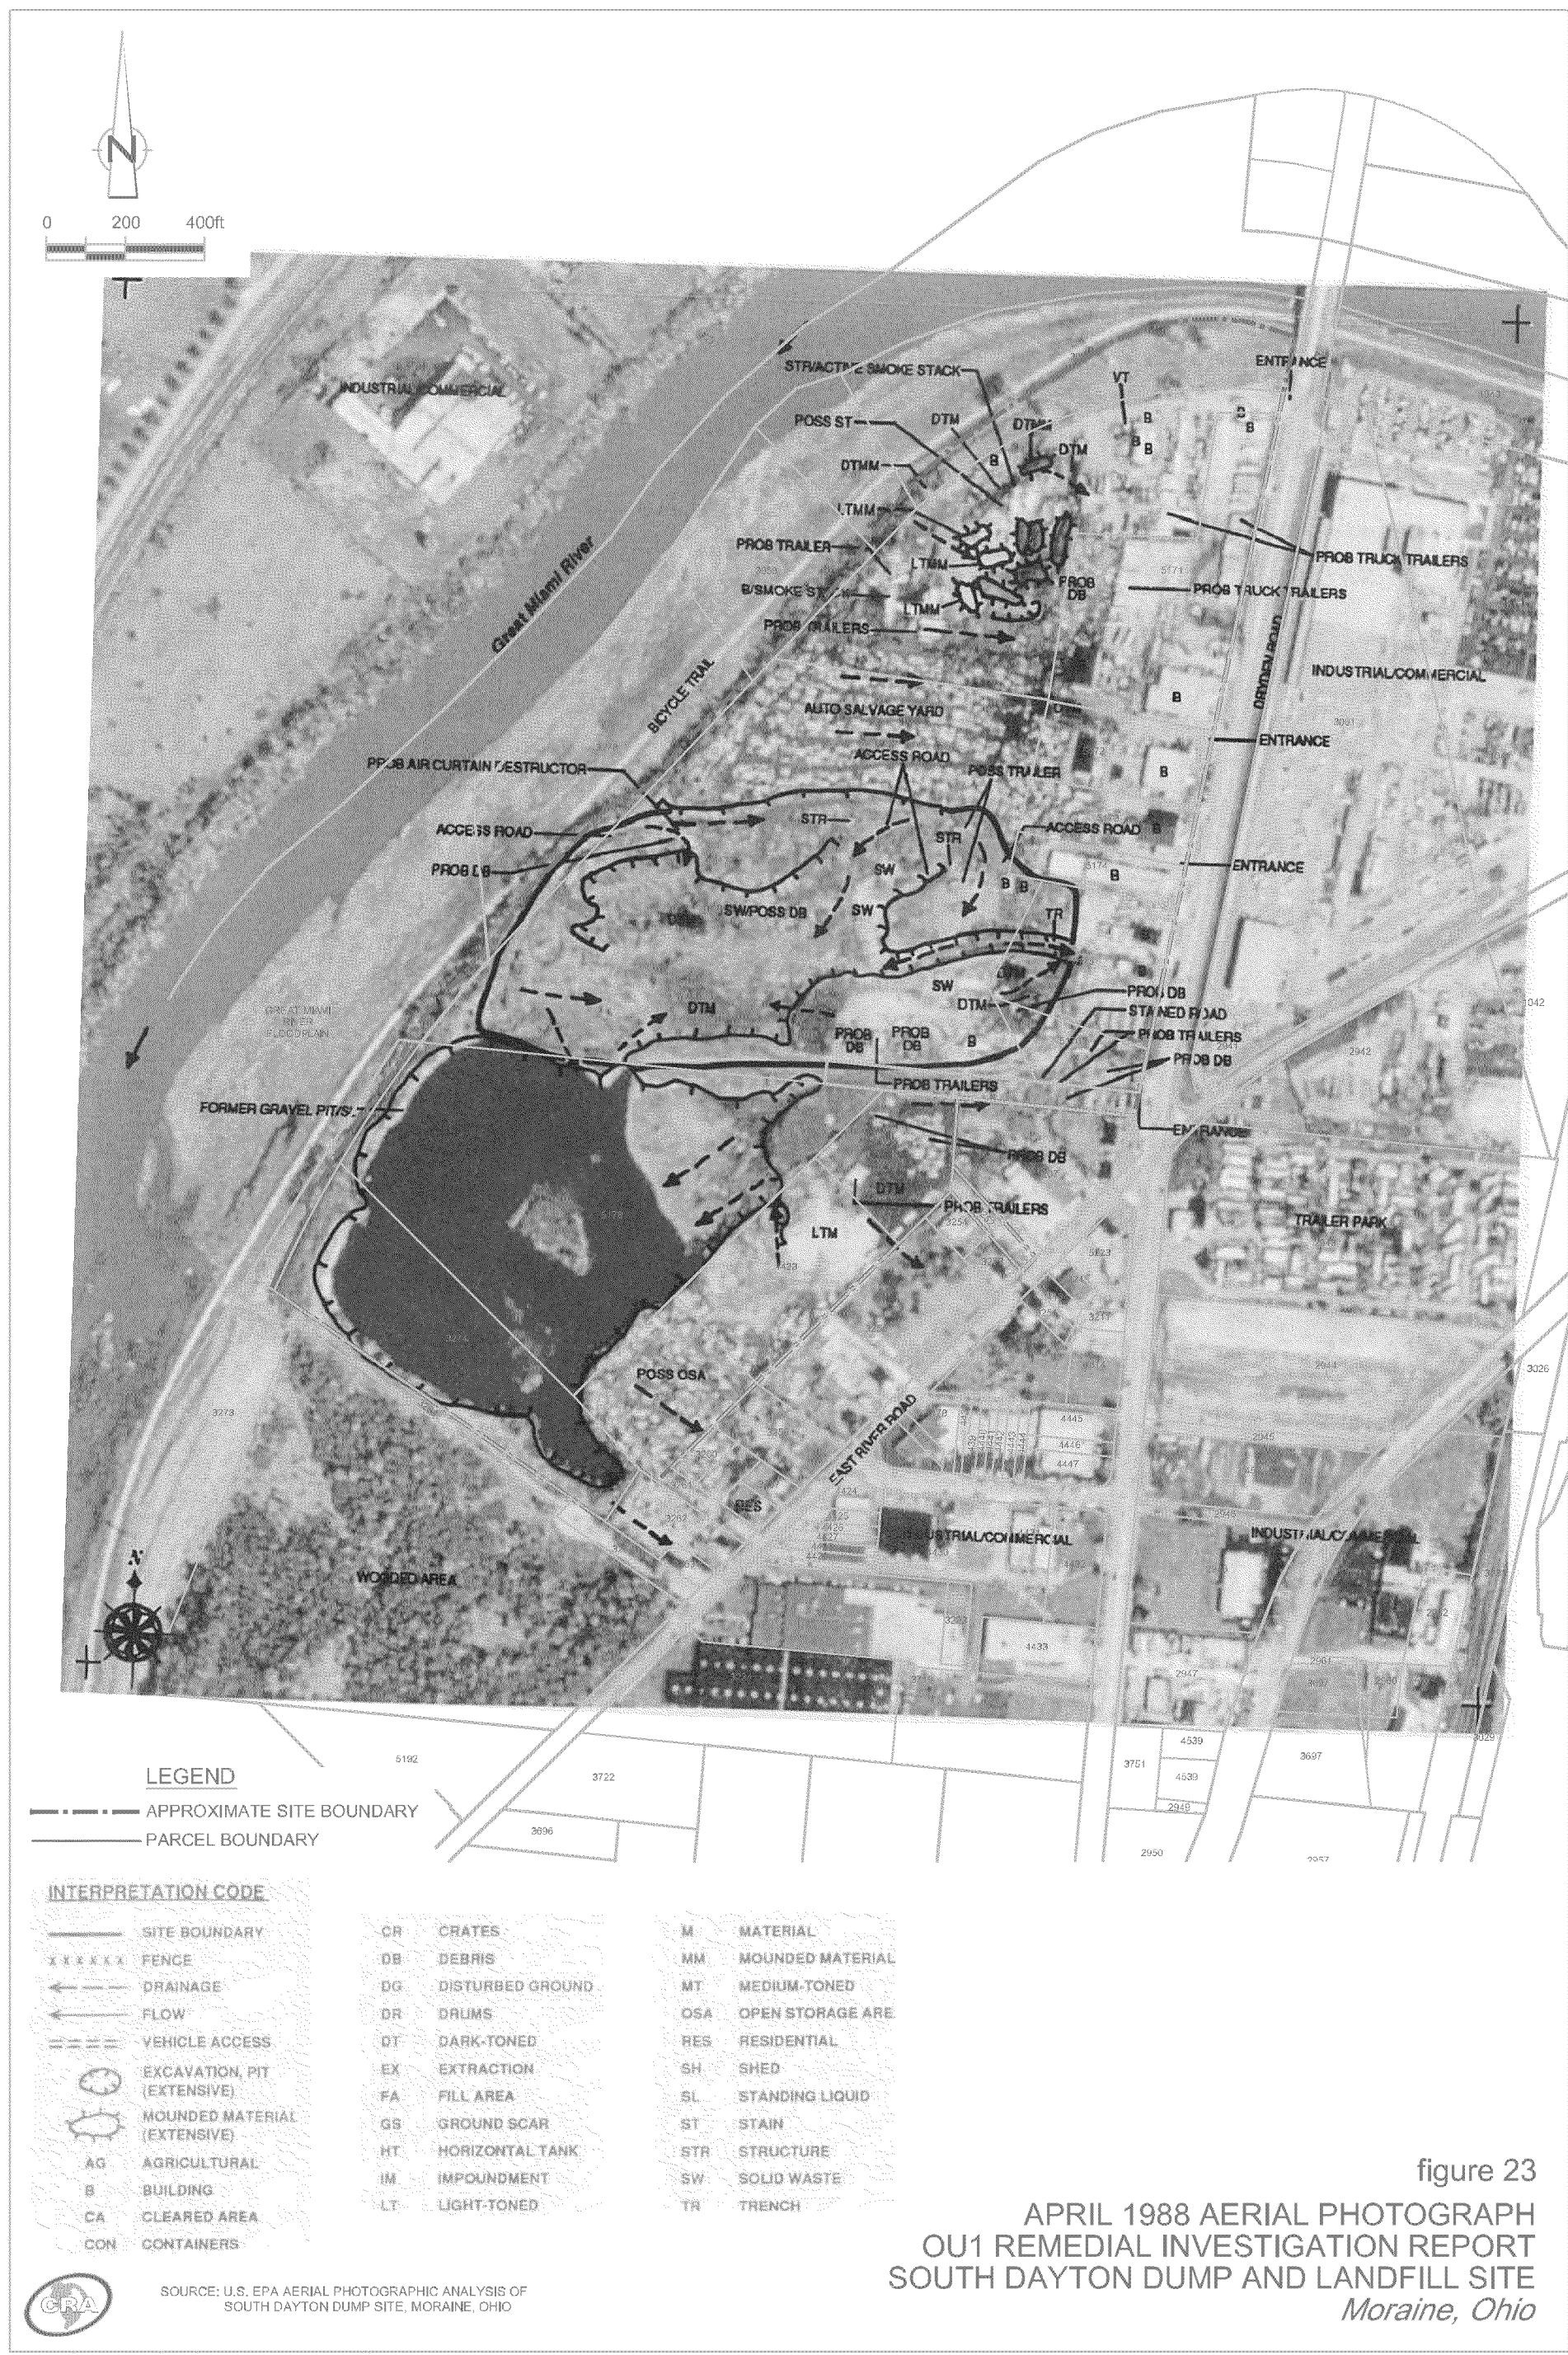
figure 23

with the Mantle Oil recycling facility, which was in operation in 1981<sup>12</sup>. In 1988, the Quarry Pond remained flooded<sup>4</sup> (Figure 23). Between 1981 and 1988, filling occurred on one of the Jim City Parcels (Parcel 4423), the southwest portion of Parcel 4610 and possibly in the northeast corner of Parcel 5178. Parcels 4423 and 4610 had reached their present grade by 1988. The Mantle Oil facility was no longer in existence by this time<sup>4</sup>.

The 1991 aerial photo (Figure 24) is of poor quality but shows little change from the 1988 aerial photograph (Figure 23). The 1993 aerial photo (Figure 12) is similar to the 1991 aerial (Figure 24) and shows filling continued on one of the Central Parcels (Parcel 5177). The 1994 aerial photo (Figure 25) is similar to the 1993 aerial photo (Figure 12) with the exception that the automobile salvage yard was no longer present in 1994. By the 1996 aerial photo (Figure 14), vegetation was present on much of one of the Central Parcels (Parcel 5177) except for a small area in the center of that parcel. The pallet recycling operations were ongoing in 1996 but filling operations had largely ceased by this time<sup>4</sup>. In 1996, Valley Asphalt's operations extended across the entirety of Parcel 5054 and had begun encroaching on Parcel 5177.<sup>4</sup>

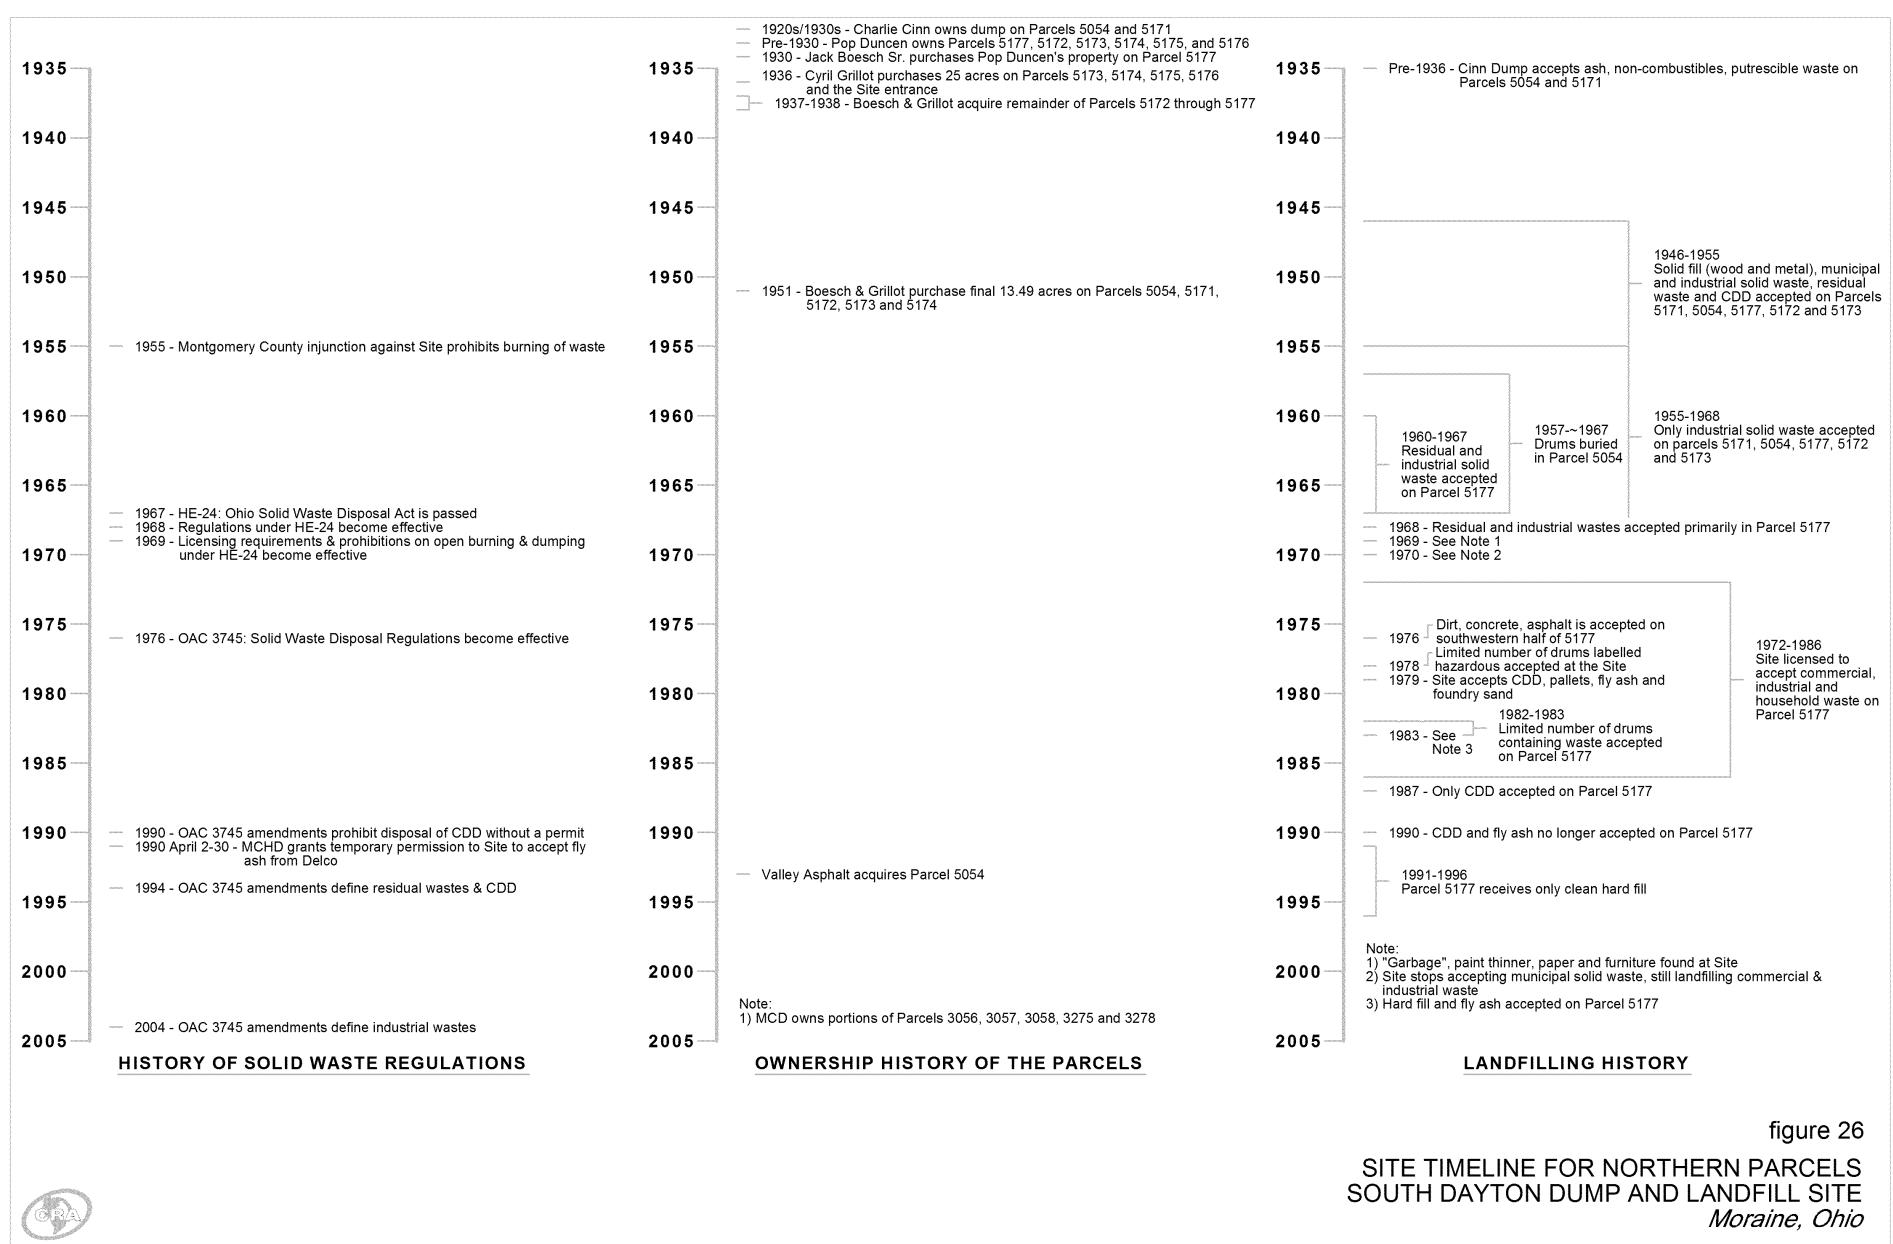
figure 26  
SITE TIMELINE FOR NORTHERN PARCELS  
SOUTH DAYTON DUMP AND LANDFILL SITE  
Moraine, Ohio

A number of different commercial and industrial activities have historically operated and continue to operate at the Site as depicted on Figures 26 and 27.
